Changes in physical and mechanical properties of soils due to anthropogenic impact on the territory of Chita

Danil D. Shesternev

Melnikov Permafrost Institute Siberian Branch, Russian Academy of Sciences. Yakutsk, Russia.

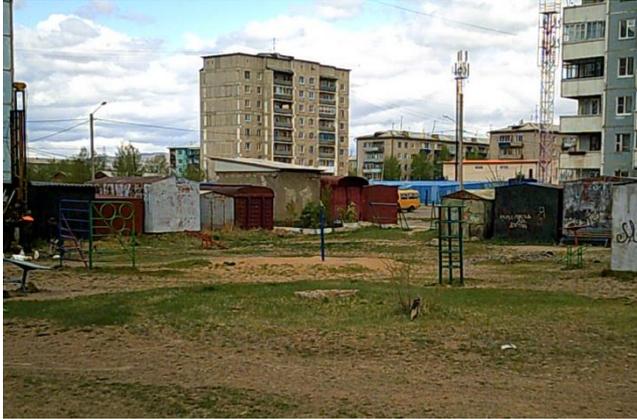
Figure 1. Construction site view before the construction onset (West)

2.4. Reconnaissance survey of the construction site and adjacent territory

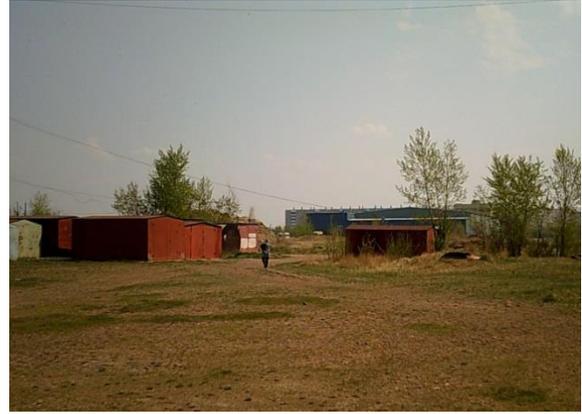
Figure 2. Construction site view before the construction onset (East)

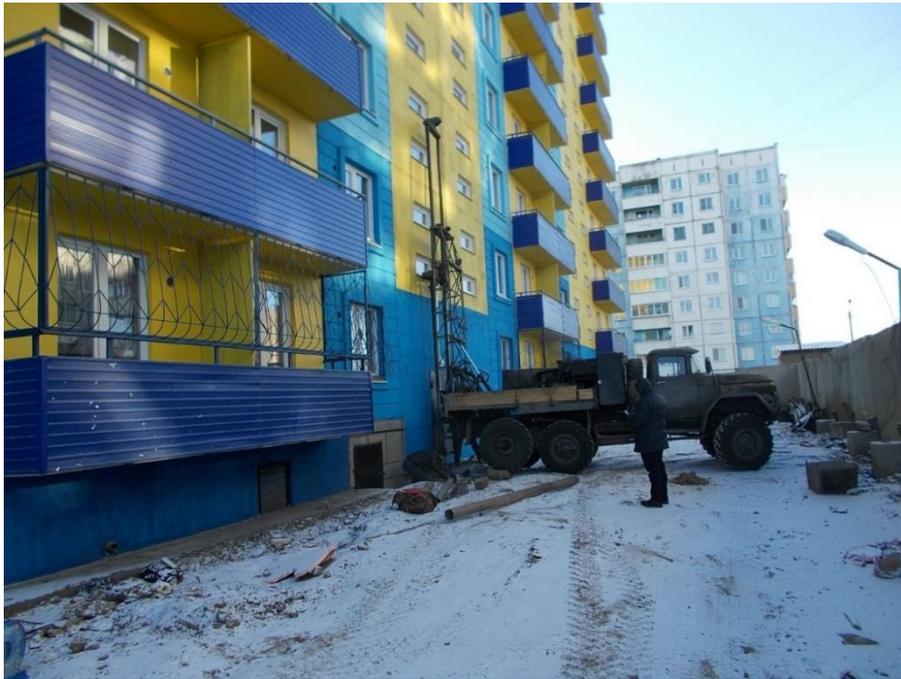
Figure 3. Drilling an engineering-geological well in 2017

Directly at the research site in 2016, 3 wells with a depth of 18 m were drilled at the construction site for a residential building. Drilling of engineering-geological wells was carried out to a depth equal to the building's area of influence on the foundation soils. These wells were drilled prior to construction. After the construction of the building in 2017, 3 wells with a depth from 5 to 8 m were drilled in close proximity to the constructed building (Figure 3). In 2018, 8 wells with a depth of 6 m were drilled along the perimeter of the building. Drilling locations for engineering-geological wells are shown in Figure 4.

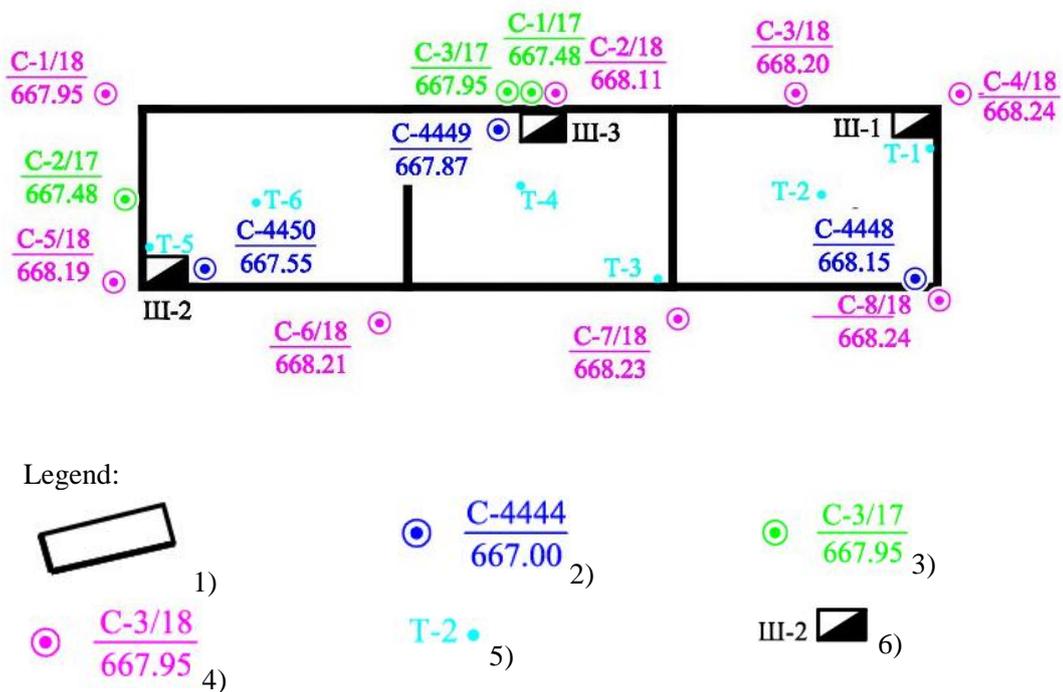
Figure 4. Layout of geotechnical works

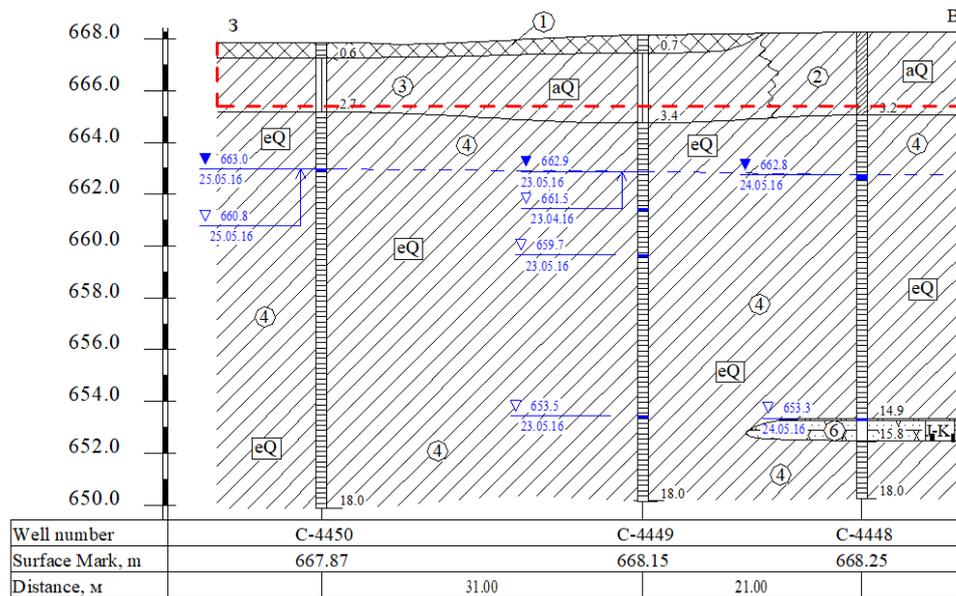
1) Filled soils; 2) loam; 3) rocky soil; 4) the contour of the pit for the building; 5) soils genesis; 6) the number of the engineering and lithological element; 7) groundwater level; 8) well in the profile cut, on the right is the depth of the layer's bottom; 9) the level of the groundwater establishment; 10) the level of the groundwater appearance

Figure 5. Engineering-geological cut of the site before the construction onset (2016)

The geological structure of the site was composed from Quaternary deposits of technogenic (tQ), alluvial (aQ) and eluvial (eQ) genesis (Figure 5). Red outline shows the border of the future foundation pit in Figure 5. The technogenic deposits were deposited to a depth of 0.7 m from the surface. The alluvial deposits were located in the upper part of the section, under the technogenic deposits. Alluvial deposits were represented by cohesive dispersed soils, loams of refractory and soft-plastic consistency. Eluvial deposits were represented by the products of weathered terrigenous-sedimentary formations of the Lower Cretaceous age. They originated from siltstones and sandstones (K1) weathered to the state of finely dispersed soils (the siltstones were destroyed to the state of loam and sandy loam, sandstone was destroyed to the state of the medium-sized sand (dispersed zone of the weathered crust). There were interlayers of weakly weathered sandstones of medium strength. The thickness of sandstone interlayers varied from 0.10-15 m to 1 m. From geocryological view, the soils were in a thawed state to a depth of 18.0 m from the surface. The upper zone of the weathering crust is more weathered (2.0 - 3.0 m) than soils that were deeper.

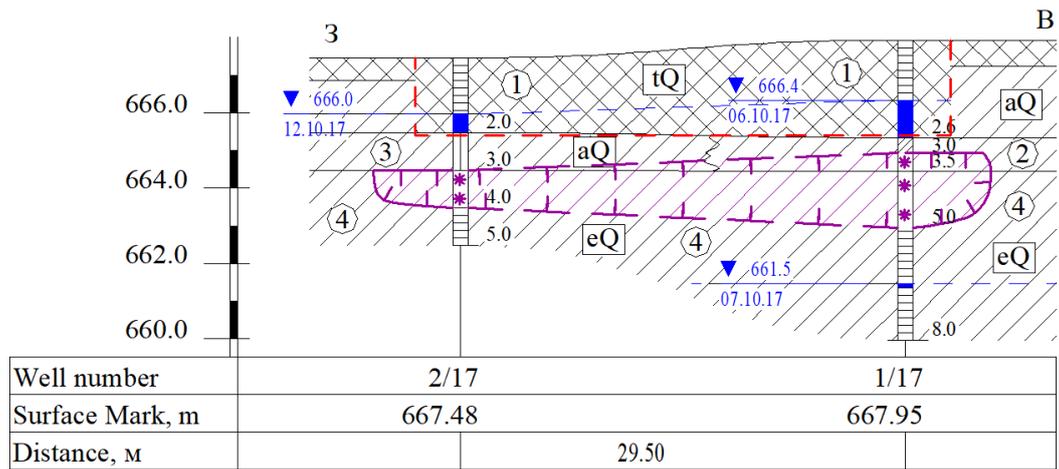
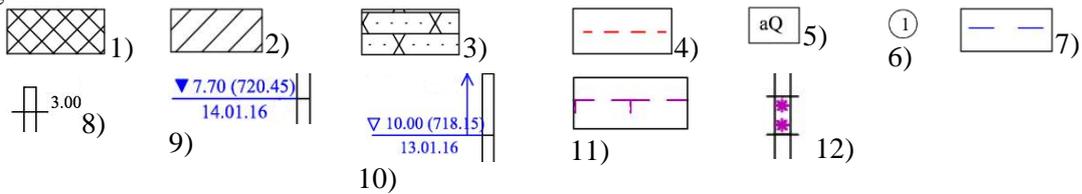
- 1) Filled soils; 2) loam; 3) rocky soil; 4) the contour of the pit for the building; 5) soils genesis; 6) the number of the engineering and lithological element; 7) groundwater level; 8) well in the profile cut, on the right is the depth of the layer's bottom; 9) the level of the groundwater establishment; 10) the level of the groundwater appearance; 11) the boundary of the frozen soils spreading (dash in the direction to the frozen soils spreading); 12) frozen soils

Figure 6. Engineering-geological cut (2017)

The changed engineering-geological section of soils is shown in Figure 6, and the changed physical and mechanical properties are shown in Table 2. In Figure 6, the red line shows the contour of the foundation pit, and the violet color shows frozen soils of a "permanent snow patch" type.

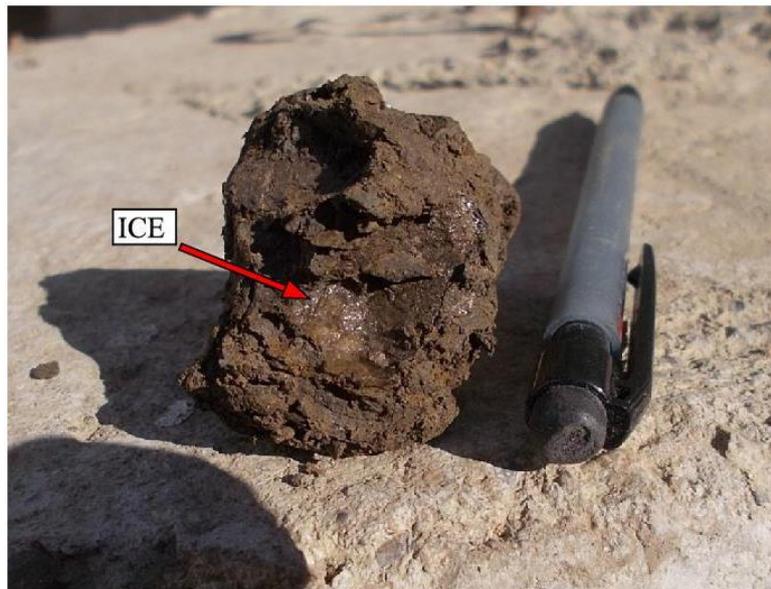
Figure 7. Frozen soils of a “permanent snow patch” type, formed after freezing of the base soils

- the second level - waters of eluvial sediments, opened at a depth of 4.5 m from the ground surface, which corresponds to marks of 663.37-663.74 m, so there was a rise in water by 1.0 m in comparison with previous surveys (Figure 7);

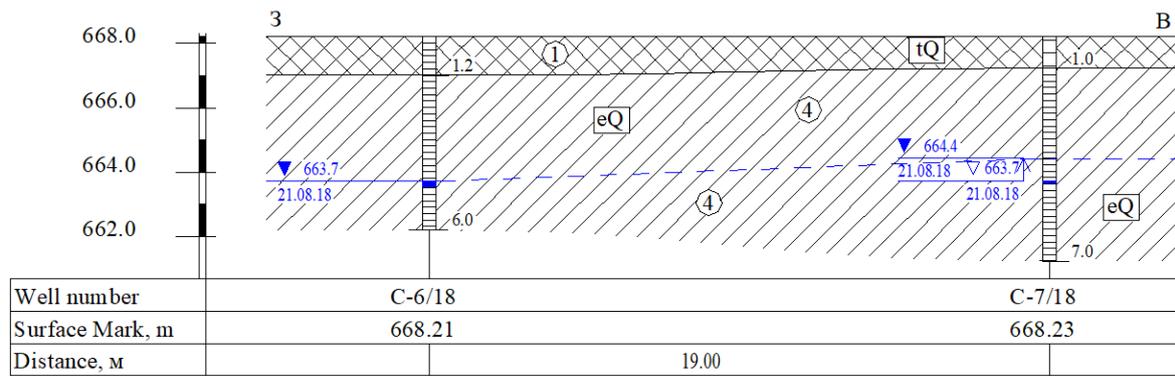
1) Filled soils; 2) loam; 3) rocky soil; 4) the contour of the pit for the building; 5) soils genesis; 6) the number of the engineering and lithological element; 7) groundwater level; 8) well in the profile cut, on the right is the depth of the layer's bottom; 9) the level of the groundwater establishment; 10) the level of the groundwater appearance

Figure 8. Engineering-geological cut of the wells located outside the pit (2018)

4.1) the geological and lithological section for wells drilled outside the pit contour is identical to the previously performed surveys (Figure 8), this indicates a change in engineering and geological conditions only within the existing structure (pit contour);

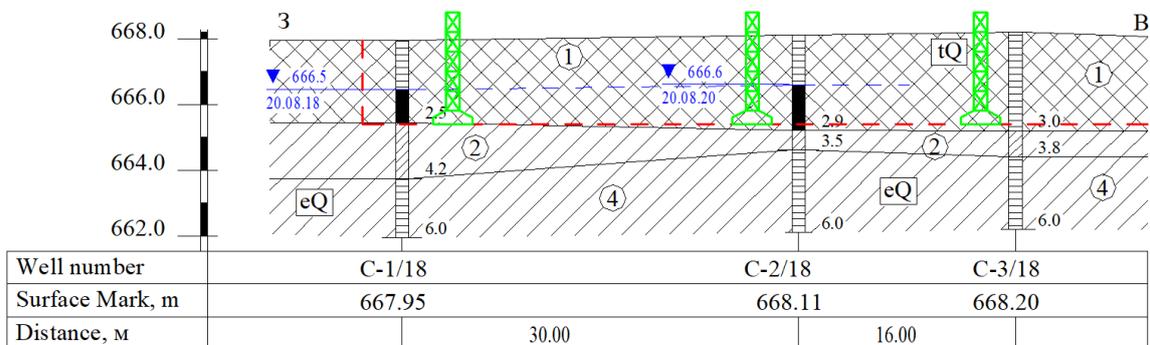
1) Filled soils; 2) loam; 3) rocky soil; 4) the contour of the pit for the building; 5) soils genesis; 6) the number of the engineering and lithological element; 7) groundwater level; 8) well in the profile cut, on the right is the depth of the layer's bottom; 9) the level of the groundwater establishment; 10) the level of the groundwater appearance; 11) building's foundations

Figure 9. Engineering-geological cut of the territory (2018)

- the first level - water of a “top water” type, which was discovered in the filled soils inside the structure at depths of 0.3-0.5 m from the basement floor and at a depth of 1.1-1.5 m from the ground surface (according to drilled engineering-geological wells and dug pits) (Figure 9);

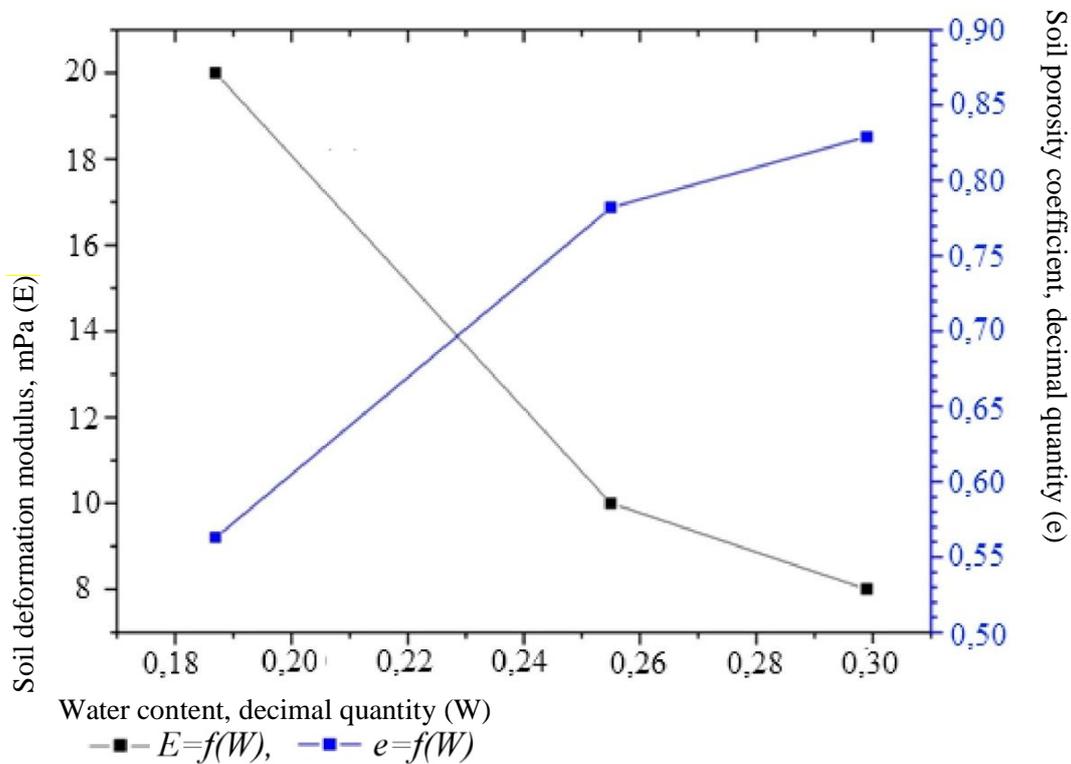
Figure 10. Graphs of changes in the deformation modulus and in the porosity coefficient at natural moisture content in alluvial loam

4.6) the soaking of soils at the base of the building continues, as the thickness of the soaked soils increased from 0.65 m to 0.90 m (2017) and then to 1.12 m (2018) (Figure 10). Consequently, the accumulation of water continues at the bottom of the pit and directly under the foundation in the compressible zone. It is also possible that there is the water inflow into the basement of the building of a technogenic kind, due to leaks from engineering networks;

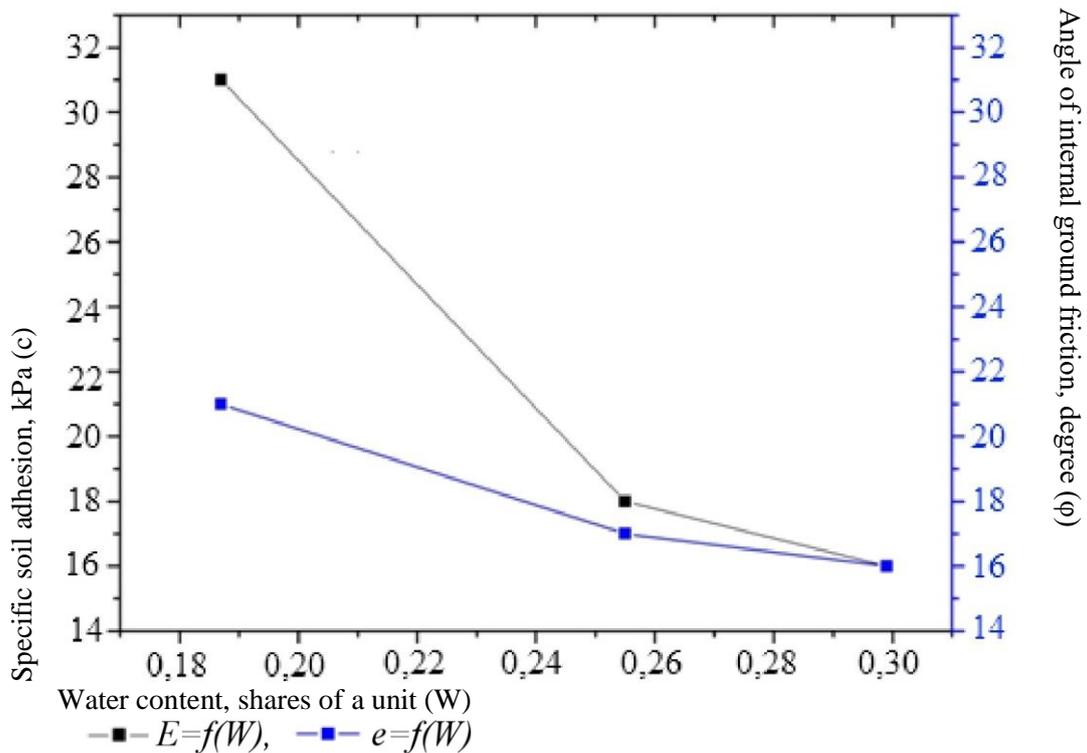
Figure 11. Graphs of changes in the adhesion and angle of internal friction at natural moisture content in alluvial loam

4.7) the dynamics of the main physical and mechanical characteristics of soils is shown in Table 3. Based on a comparison of data from this table, it can be seen that with an increase in natural moisture, fluidity index, porosity coefficient, the density of EGE-2 soil (soft-plastic loam) decreases, which leads to decrease in the deformation and strength characteristics of the soil (Figures 10, 11). Refractory loam (EGE-3), due to soaking, became soft-plastic loam (EGE-2). Based on a comparison of the data from Table 3, it can be concluded that an increase in the porosity of alluvial loams was a consequence of the soils freezing in the foundation pit. So, an increase in the consistency index and a decrease in the deformation modulus was caused by freezing and subsequent thawing under soaking conditions. At the same time, it can be seen from this table that the characteristics of eluvial soils, which lie in the lower part of the section, remained unchanged and retained their deformation and strength properties.
